Thermal Imaging Report

Inspection Ref. TI BUILDING DEMO (BUILDING)

TI LTD / TI BUILD DEMO

Purpose of Survey	INTEGRITY ASSESSMENT OF BUILDING ENVELOPE AND ENERGY LOSS INVESTIGATION
Reason for Survey	BREEAM ASSESSMENT
Applicable Formulas	YES - THERMAL INDEXING
Inspection Commencing	07:00
Weather	DRY
Wind Speed	<5MPH M/S
Mean Ambient Temperature Internal °C	17.0 °C
Mean Ambient Temperature External °C	6.0 °C
Temperature Delta between Internal and External °C	11.0 °C
Thermographer, Certification and ID	RICHARD WALLACE - LEVEL 2 THERMOGRAPHY - 49595
Camera	FLIR THERMACAM P640
Software	TICOR™ ANDROID DATA CAPTURE AND REPORTING APPLICATION LINKED TO WEBCOR™ ONLINE CAMPAIGN MANAGER - BUILDING MODULE
Company Accreditation	ISO9001-2008 - GB2003936
Building Reference Documents	IP1/06, BRE443, BSRIA BG39/2100
Survey BS Accordance	BS EN 13187:1999 THERMAL PERFORMANCE OF BUILDINGS

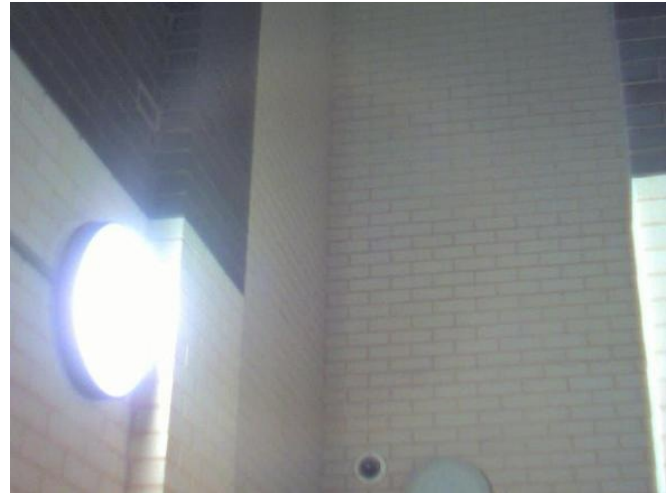
Client	Asset	Report Date	Problem #	Problem Type	Fault Rating	Problem Status
TI LTD	TI BUILD DEMO	18/06/2015	1	THERMAL	NO ISSUE	■ OPEN

Problem	
Anomaly	ELEVATED AR1
Root Cause	SUSPECTED THERMAL BRIDGE FROM INTERNAL DETAIL
Remedial	CHECK DETAIL IS TO PRESCRIBED STANDARD, IF REQUIRED ADD APPROPRIATE INSULATION TO REDUCE THERMAL/COLD BRIDGE

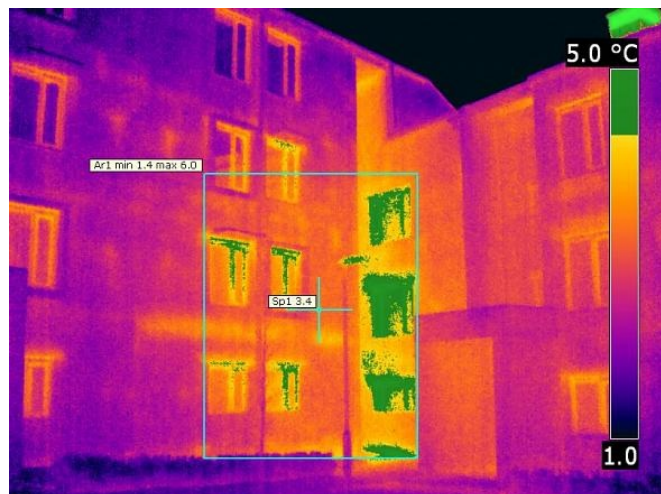
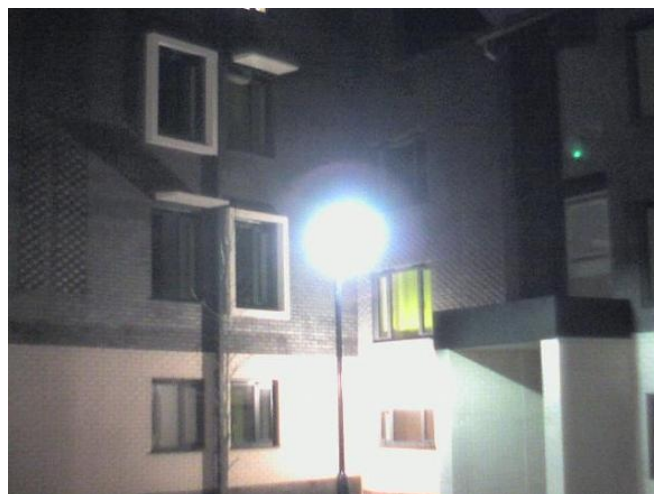
Client	Asset	Report Date	Problem #	Problem Type	Fault Rating	Problem Status
TI LTD	TI BUILD DEMO	18/06/2015	2	THERMAL	NO ISSUE	■ OPEN

Problem	
Anomaly	ELEVATED AR1
Root Cause	SUSPECTED AIR LEAKAGE AND INSULATION INCONTINUITY
Remedial	CHECK SEALS AND REPAIR OR REPLACE WHERE NECESSARY

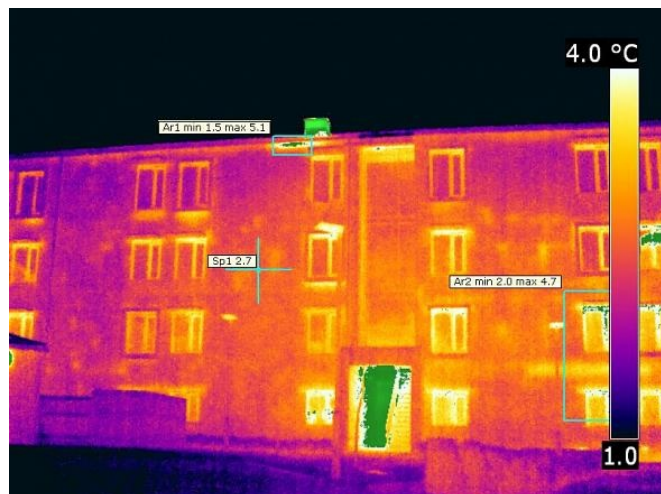
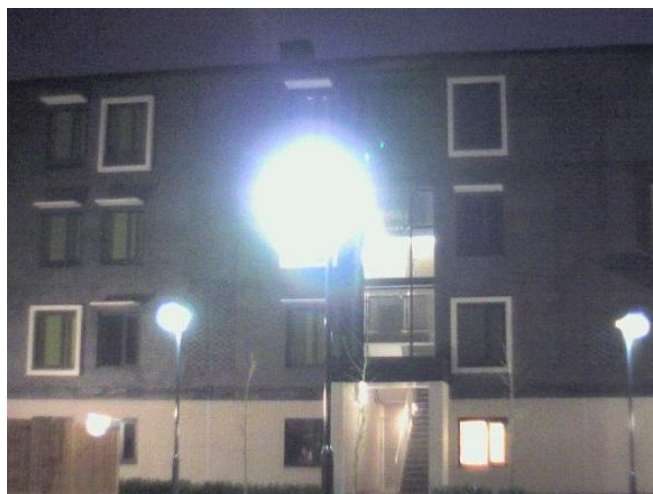
Client	Asset	Report Date	Problem #	Problem Type	Fault Rating	Problem Status
TI LTD	TI BUILD DEMO	18/06/2015	3	THERMAL	NO ISSUE	■ OPEN

Problem	
Anomaly	ELEVATED AR1 AND AR2
Root Cause	SUSPECTED AIR LEAKAGE AND INSULATION INCONTINUITY
Remedial	CHECK SEALS AND REPAIR OR REPLACE WHERE NECESSARY

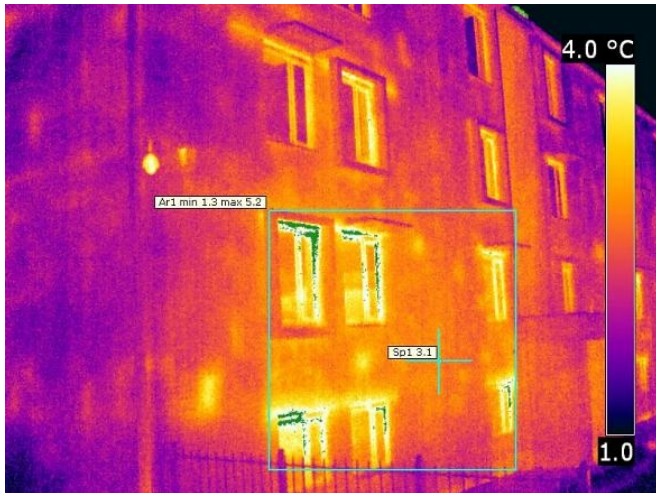
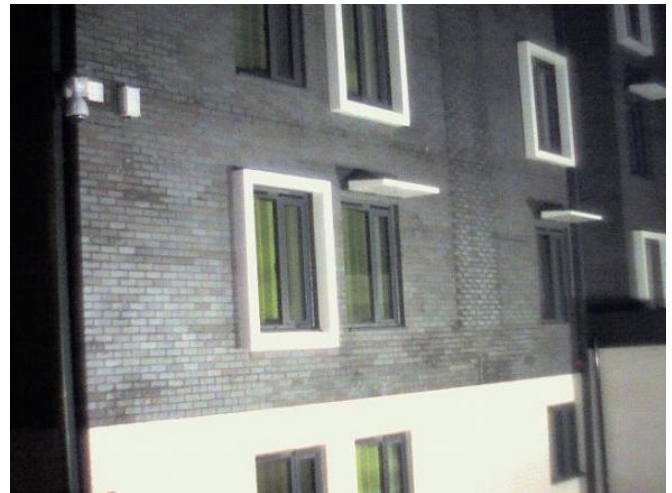
Client	Asset	Report Date	Problem #	Problem Type	Fault Rating	Problem Status
TI LTD	TI BUILD DEMO	18/06/2015	4	THERMAL	NO ISSUE	■ OPEN

Problem	
Anomaly	ELEVATED AR1
Root Cause	SUSPECTED AIR LEAKAGE
Remedial	CHECK SEALS AND REPAIR OR REPLACE WHERE NECESSARY

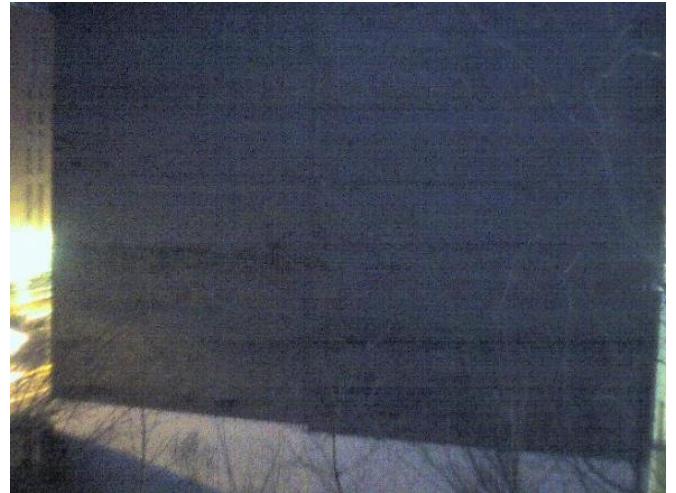
Client	Asset	Report Date	Problem #	Problem Type	Fault Rating	Problem Status
TI LTD	TI BUILD DEMO	18/06/2015	5	THERMAL	NO ISSUE	■ OPEN

Problem	
Anomaly	ELEVATED AR1
Root Cause	SUSPECTED INSULATION INCONTINUITY
Remedial	REPAIR, ADD OR REPLACE INSULATION AS REQUIRED FOLLOWING INVESTIGATION

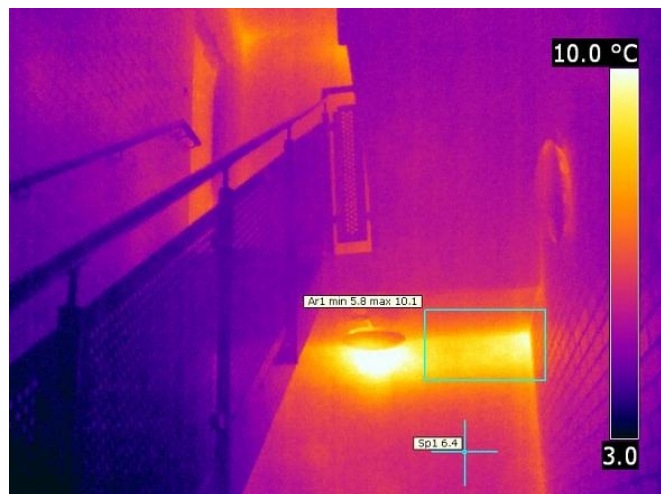
Client	Asset	Report Date	Problem #	Problem Type	Fault Rating	Problem Status
TI LTD	TI BUILD DEMO	18/06/2015	6	THERMAL	NO ISSUE	■ OPEN

Problem	
Anomaly	ELEVATED AR1
Root Cause	SUSPECTED THERMAL BRIDGE FROM INTERNAL DETAIL
Remedial	REPAIR, ADD OR REPLACE INSULATION AS REQUIRED FOLLOWING INVESTIGATION

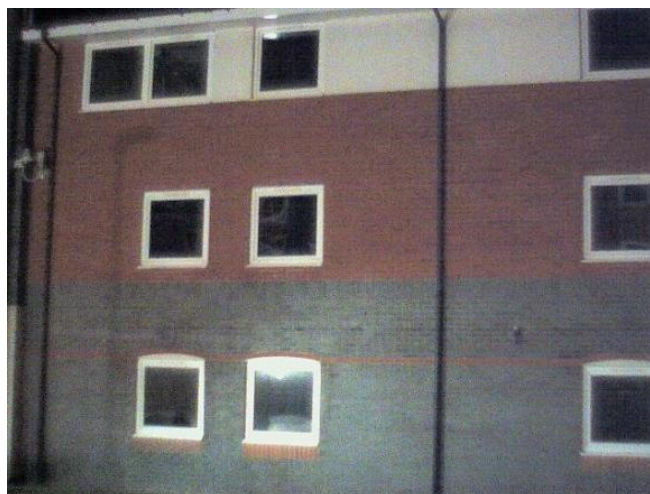
Client	Asset	Report Date	Problem #	Problem Type	Fault Rating	Problem Status
TI LTD	TI BUILD DEMO	18/06/2015	7	THERMAL	NO ISSUE	■ OPEN

Problem	
Anomaly	ELEVATED AR1 AND AR2
Root Cause	SUSPECTED THERMAL BRIDGE FROM INTERNAL DETAIL
Remedial	CHECK SEALS AND REPAIR OR REPLACE WHERE NECESSARY

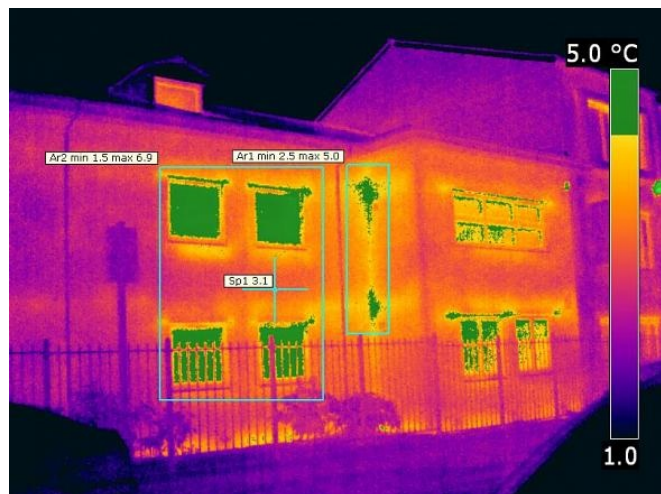
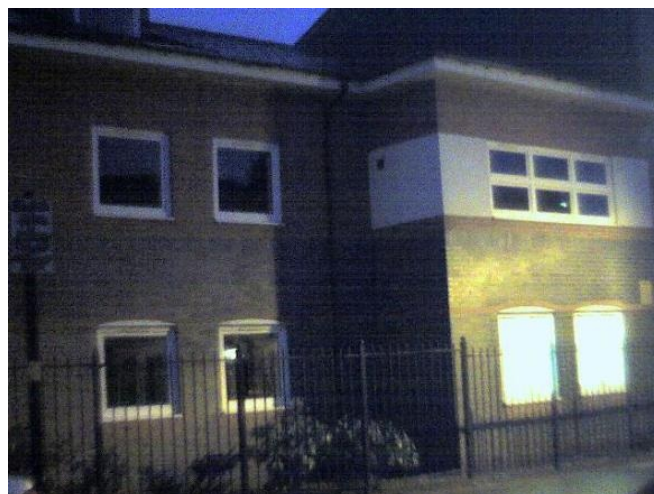
Client	Asset	Report Date	Problem #	Problem Type	Fault Rating	Problem Status
TI LTD	TI BUILD DEMO	18/06/2015	8	THERMAL	NO ISSUE	■ OPEN

Problem	
Anomaly	ELEVATED AR1 AND AR2
Root Cause	SUSPECTED AIR LEAKAGE, INSULATION INCONTINUITY AND THERMAL BRIDGE
Remedial	REPAIR, ADD OR REPLACE INSULATION AS REQUIRED FOLLOWING INVESTIGATION

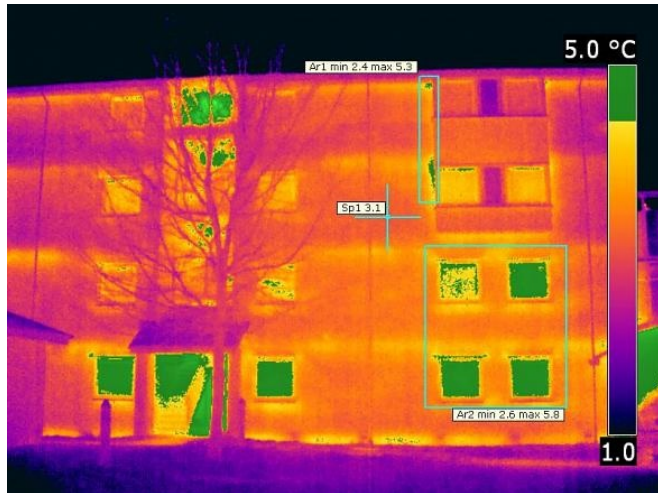
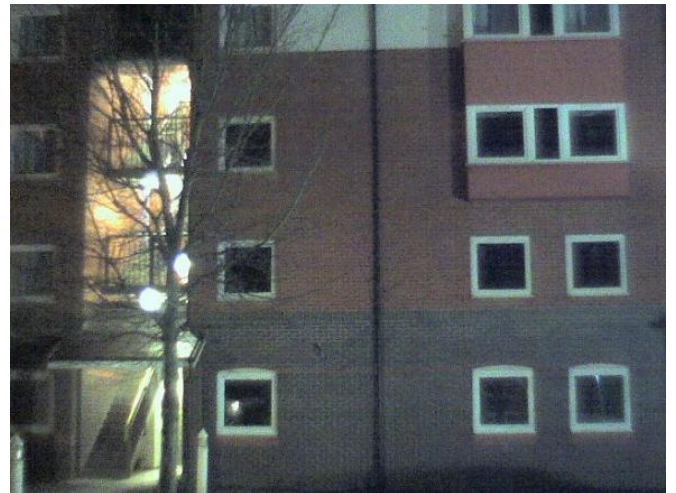
Client	Asset	Report Date	Problem #	Problem Type	Fault Rating	Problem Status
TI LTD	TI BUILD DEMO	18/06/2015	9	THERMAL	NO ISSUE	■ OPEN

Problem	
Anomaly	DECREASED AR1 AND AR2
Root Cause	SUSPECTED AIR LEAKAGE AND INSULATION INCONTINUITY
Remedial	CHECK SEALS AND REPAIR OR REPLACE WHERE NECESSARY

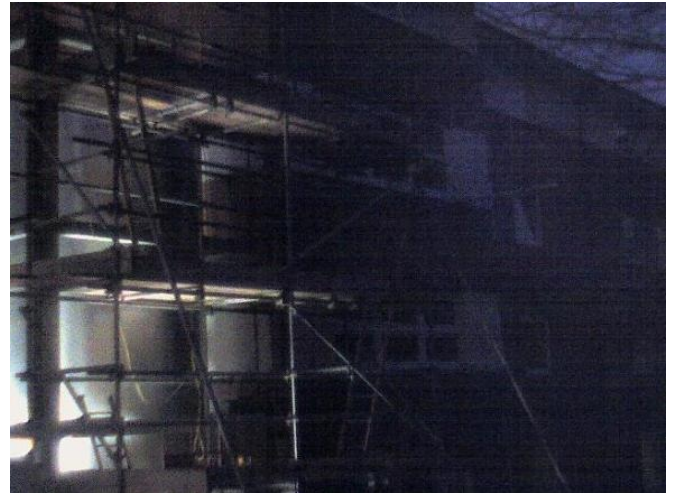
Client	Asset	Report Date	Problem #	Problem Type	Fault Rating	Problem Status
TI LTD	TI BUILD DEMO	18/06/2015	10	THERMAL	NO ISSUE	■ OPEN

Problem	
Anomaly	ELEVATED AR1
Root Cause	ENERGY LOSS THROUGH WINDOWS
Remedial	CONSIDER UPGRADING TO MORE ENERGY EFFICIENT GLAZING

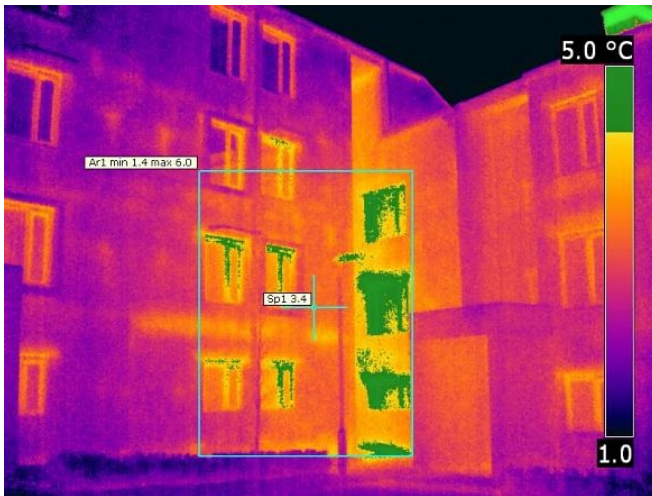
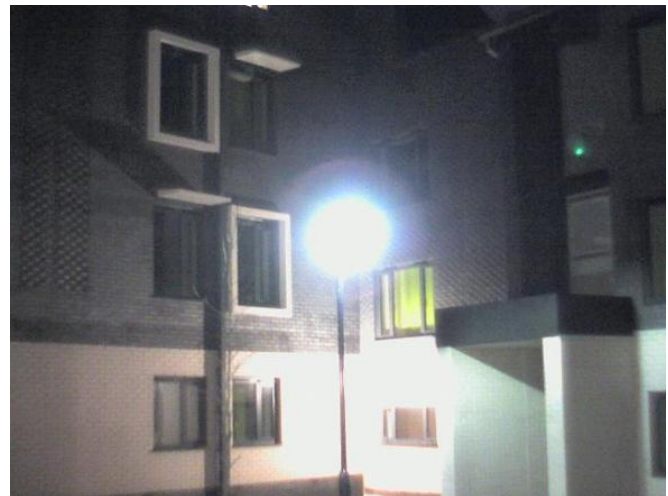
Location/Equipment Information	
Location	MAIN BUILDING > SOUTH
Component	BLOCK C
Item ID	
Area Specific	NONE
Work Order	N/A
Problem

Thermal Information	
Internal Ambient Temp (Ti)	°C
Internal Surface Temp (Tsi)	16.0 °C
External Ambient Temp (Te)	°C
External Surface Temp (Tse)	3.5 °C
Calculated Internal Threshold Surface Temp. (Isotherm below)	°C
Calculated External Threshold Surface Temp. (Isotherm above)	4.4 °C
Internal Surface Temp. (Tsi) measured anomaly	°C
External Surface Temp (Tse) measured anomaly	6.0 °C

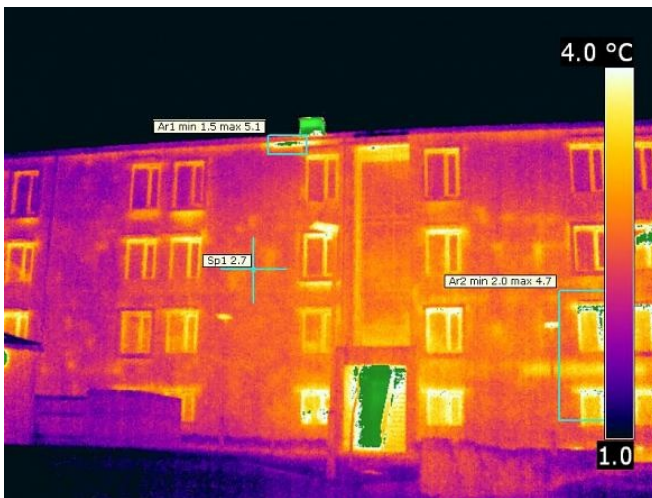
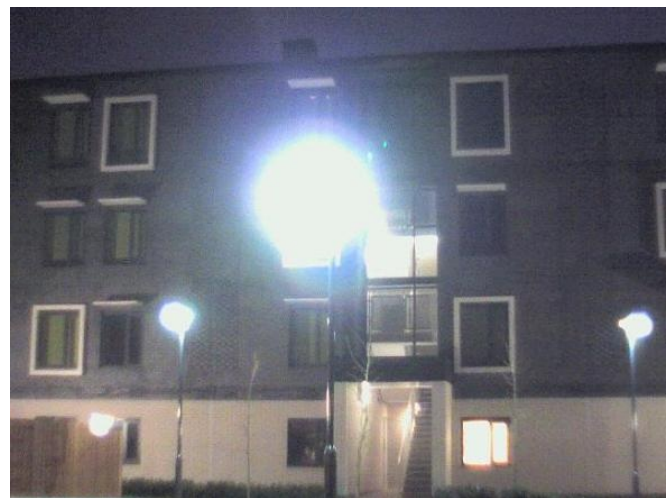
Location/Equipment Information	
Location	MAIN BUILDING > SOUTH
Component	BLOCK B
Item ID	
Area Specific	NONE
Work Order	N/A
Problem	AT SOFFIT AND WINDOWS

Thermal Information	
Internal Ambient Temp (Ti)	°C
Internal Surface Temp (Tsi)	16.0 °C
External Ambient Temp (Te)	°C
External Surface Temp (Tse)	3.5 °C
Calculated Internal Threshold Surface Temp. (Isotherm below)	°C
Calculated External Threshold Surface Temp. (Isotherm above)	4.4 °C
Internal Surface Temp. (Tsi) measured anomaly	°C
External Surface Temp (Tse) measured anomaly	6.0 °C

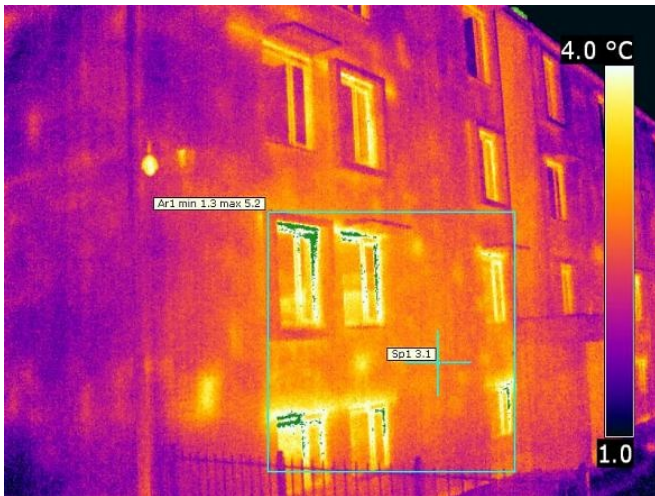
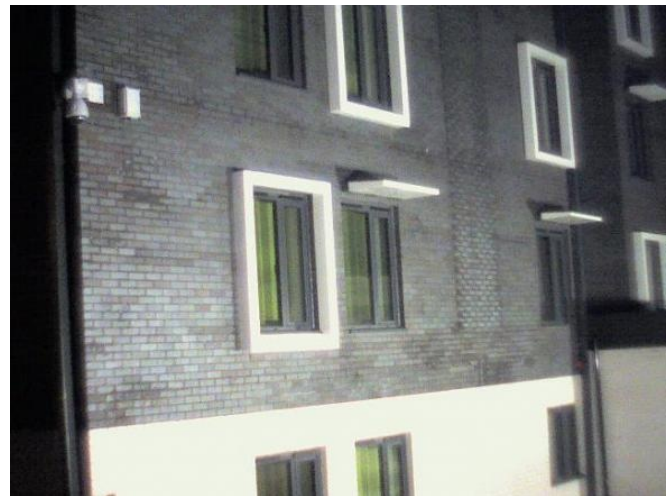
Location/Equipment Information	
Location	MAIN BUILDING > SOUTH
Component	BLOCK A
Item ID	
Area Specific	NONE
Work Order	N/A
Problem

Thermal Information	
Internal Ambient Temp (Ti)	°C
Internal Surface Temp (Tsi)	16.0 °C
External Ambient Temp (Te)	°C
External Surface Temp (Tse)	3.5 °C
Calculated Internal Threshold Surface Temp. (Isotherm below)	°C
Calculated External Threshold Surface Temp. (Isotherm above)	4.4 °C
Internal Surface Temp. (Tsi) measured anomaly	°C
External Surface Temp (Tse) measured anomaly	6.0 °C

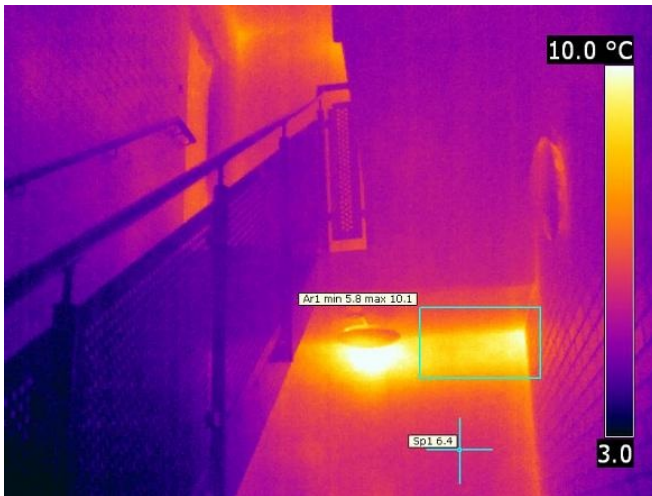
Location/Equipment Information	
Location	MAIN BUILDING > WEST
Component	BLOCK C STAIRWELL
Item ID	
Area Specific	NONE
Work Order	N/A
Problem

Thermal Information	
Internal Ambient Temp (Ti)	°C
Internal Surface Temp (Tsi)	16.0 °C
External Ambient Temp (Te)	°C
External Surface Temp (Tse)	3.5 °C
Calculated Internal Threshold Surface Temp. (Isotherm below)	°C
Calculated External Threshold Surface Temp. (Isotherm above)	4.4 °C
Internal Surface Temp. (Tsi) measured anomaly	°C
External Surface Temp (Tse) measured anomaly	11.0 °C

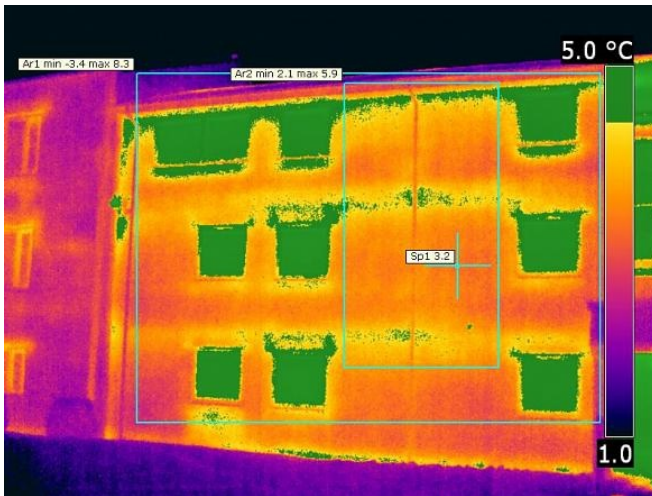
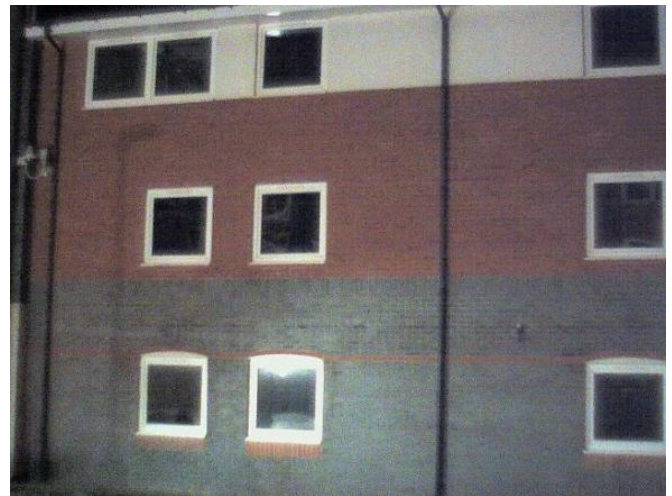
Location/Equipment Information	
Location	THREE STOREY REFURB
Component	WEST
Item ID	
Area Specific	NONE
Work Order	N/A
Problem

Thermal Information	
Internal Ambient Temp (Ti)	°C
Internal Surface Temp (Tsi)	16.6 °C
External Ambient Temp (Te)	°C
External Surface Temp (Tse)	3.0 °C
Calculated Internal Threshold Surface Temp. (Isotherm below)	°C
Calculated External Threshold Surface Temp. (Isotherm above)	4.0 °C
Internal Surface Temp. (Tsi) measured anomaly	°C
External Surface Temp (Tse) measured anomaly	8.0 °C

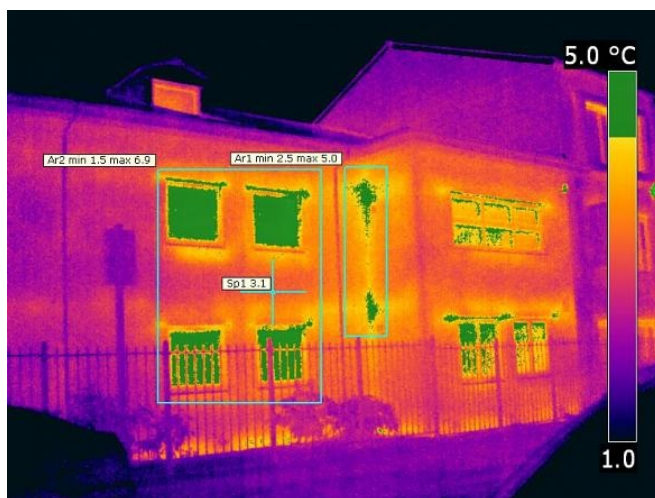
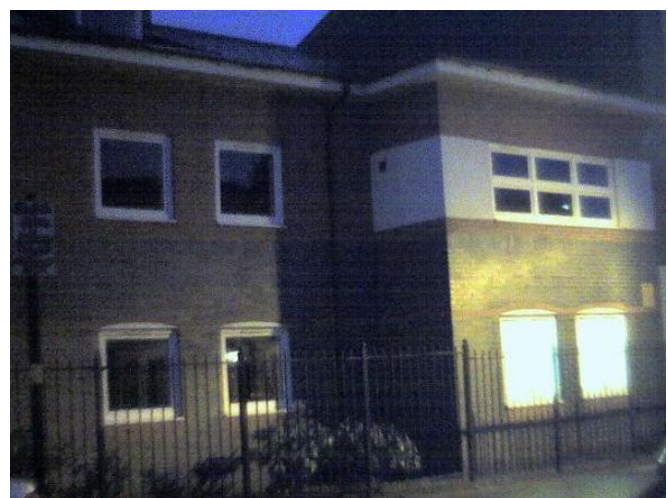
Location/Equipment Information	
Location	THREE STOREY REFURB
Component	EAST
Item ID	
Area Specific	NONE
Work Order	N/A
Problem

Thermal Information	
Internal Ambient Temp (Ti)	°C
Internal Surface Temp (Tsi)	16.0 °C
External Ambient Temp (Te)	°C
External Surface Temp (Tse)	3.5 °C
Calculated Internal Threshold Surface Temp. (Isotherm below)	°C
Calculated External Threshold Surface Temp. (Isotherm above)	4.4 °C
Internal Surface Temp. (Tsi) measured anomaly	°C
External Surface Temp (Tse) measured anomaly	7.0 °C

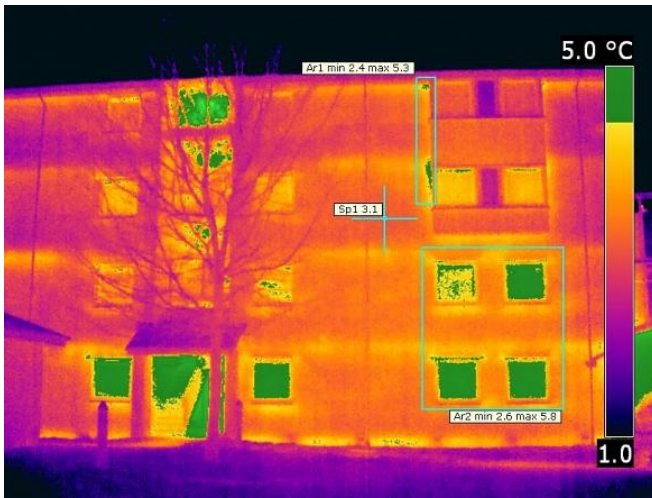
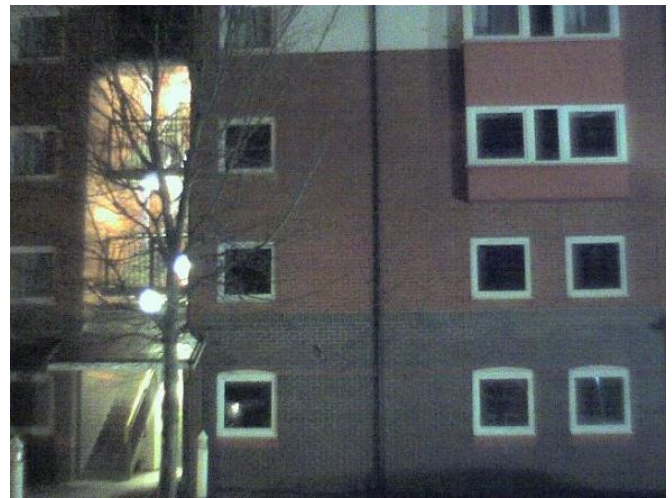
Location/Equipment Information	
Location	FOUR STOREY REFURB
Component	EAST
Item ID	
Area Specific	NONE
Work Order	N/A
Problem

Thermal Information	
Internal Ambient Temp (Ti)	°C
Internal Surface Temp (Tsi)	15.9 °C
External Ambient Temp (Te)	°C
External Surface Temp (Tse)	3.5 °C
Calculated Internal Threshold Surface Temp. (Isotherm below)	°C
Calculated External Threshold Surface Temp. (Isotherm above)	4.4 °C
Internal Surface Temp. (Tsi) measured anomaly	°C
External Surface Temp (Tse) measured anomaly	5.3 °C
