ti thermal imaging ltd.

Thermal Imaging Report

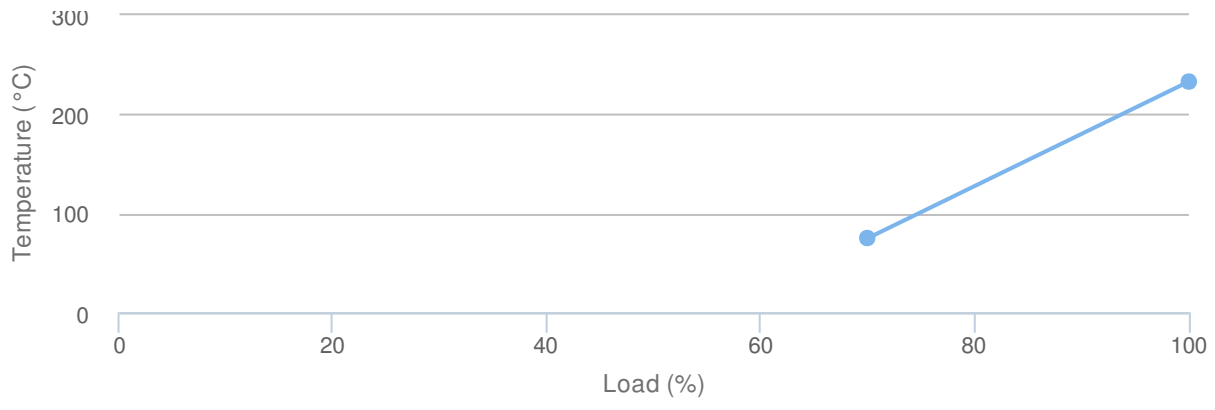
Trending Data	
Measured Temp.	138 °C
Ambient Temp.	24 °C
Nominal Maximum Current	100.0 AMPS
Measured Current	68.0 AMPS
Reference Temp. (BS7671 ref cable temp 65-85 °C)	75 °C
Temp. Rise Over Ambient	114.0 °C
Load Factor	0.7 %
Temperature Load Corrected	233.1 °C
Excess of Ref Temp.	158.6 °C
Max Load To Safely Apply Remaining Beneath Ref Temp.	40.7 AMPS
Voltage	412 VOLTS
L1 Load	62 AMPS
L2 Load	68 AMPS
L3 Load	66 AMPS
Neutral Load	AMPS
Ultrasonic Reading	DBUV

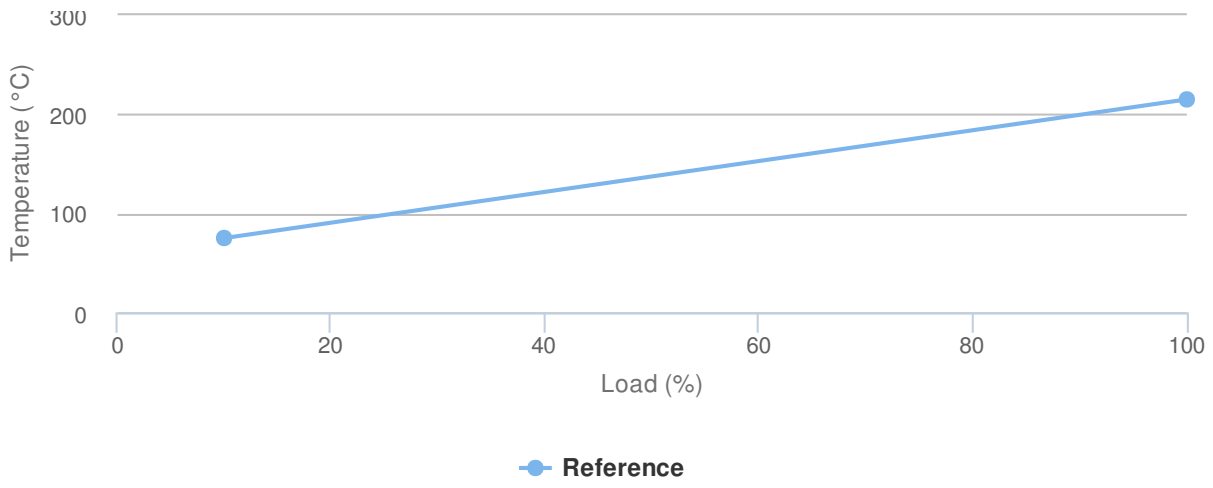
Trending Data	
Measured Temp.	29.0 °C
Ambient Temp.	24.0 °C
Nominal Maximum Current	100.0 AMPS
Measured Current	12.0 AMPS
Reference Temp. (BS7671 ref cable temp 65-85 °C)	75.0 °C
Temp. Rise Over Ambient	5.0 °C
Load Factor	0.1 %
Temperature Load Corrected	215.8 °C
Excess of Ref Temp.	141.3 °C
Max Load To Safely Apply Remaining Beneath Ref Temp.	53.3 AMPS
Voltage	240.0 VOLTS
L1 Load	12.0 AMPS
L2 Load	0.0 AMPS
L3 Load	0.0 AMPS
Neutral Load	12.0 AMPS
Ultrasonic Reading	DBUV
